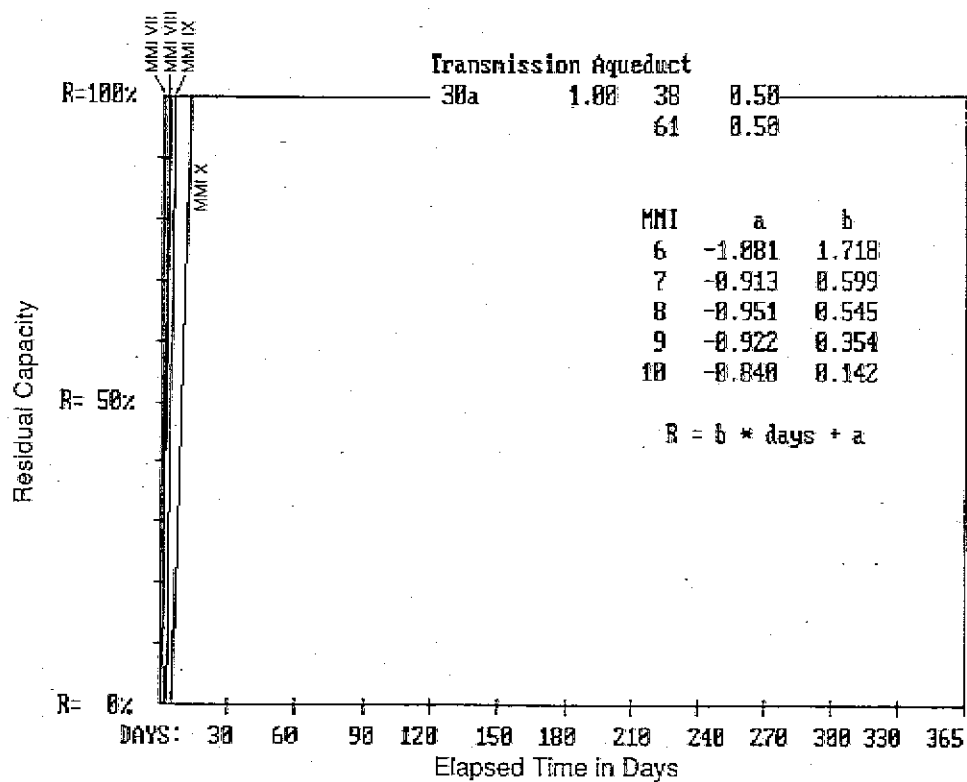
Figure B-65 Residual capacity for transmission aqueducts (NEHRP Map Area: California 3-6, California 7, Non-California 7, and Puget Sound 5).
